**Flood Control Project Maintenance
Levee Inspections**
LMA District Cover Sheet
Spring 2011 Levee Inspection Results

Reclamation District No. 2095 Paradise Cut

Levee Inspection Report By Mile - Spring 2011

Waterway	Bank	Unit Miles	Inspection Start/End	Inspector
Unit No. 01 Paradise Cut	Left	1.45	04/27/2011 04/27/2011	Jim Eto

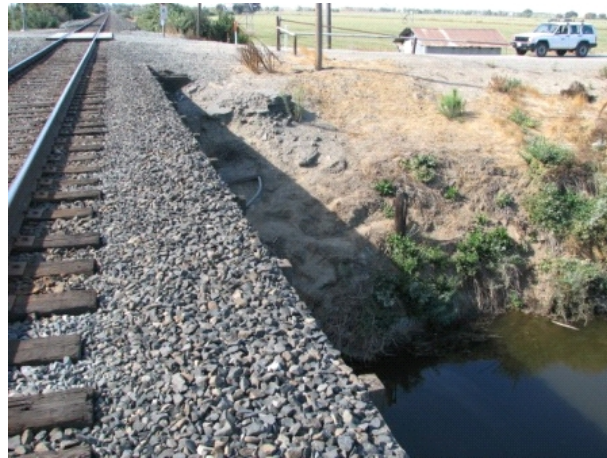
Levee Mile Report Line	6
Start Levee Mile	0.73
End Levee Mile	0.74
Location	Water Side
Category	Supplemental
Item	DWR Erosion Survey

5	0.70	0.70	Earthen Levee	Encroachments	LS	PO	Buildings Inspector Comments: Pump house near RR.	37.763630 ° -121.319045 °	37.763630 ° -121.319045 °	11
6	0.73	0.74	Supplemental	DWR Erosion Survey	WS	M	Inspector Comments: 09/22/2010: No significant changes observed on site. There is now considerable vegetation at the water line and along the lower berm slope. However, the erosion on the lower berm slope is still present and has not been corrected. 08/06/2010: Recommended	37.763630 ° -121.319000 °	37.763630 ° -121.319000 °	2 Y
7	0.86	0.86	Supplemental	DWR Erosion Survey	WS	U	Inspector Comments: 09/22/2010: No significant changes observed. Sloughing of the existing rip rap possibly due to a combination of steep slope and undesirable flood conditions. 08/06/2010: Recommended as local maintenance issue, per CLRO. [2010 SiteID: RD2095U01RM6.88]	37.761960 ° -121.318140 °	37.761960 ° -121.318140 °	1 Y

Downstream view of site.

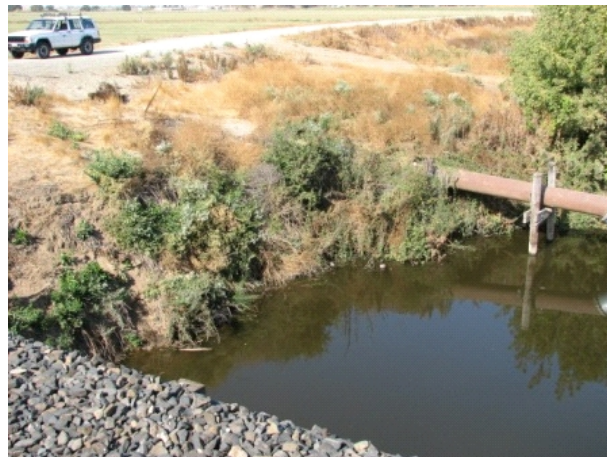
Levee Mile Report Line	6
Start Levee Mile	0.73
End Levee Mile	0.74
Location	Water Side
Category	Supplemental
Item	DWR Erosion Survey

Downstream view of site looking from the RxR crossing.

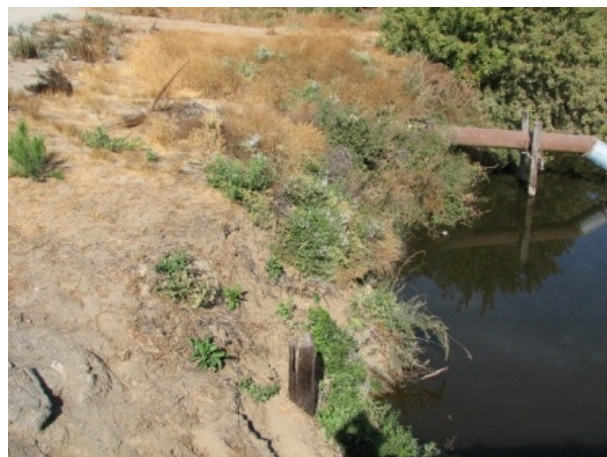
Levee Mile Report Line	6
Start Levee Mile	0.73
End Levee Mile	0.74
Location	Water Side
Category	Supplemental
Item	DWR Erosion Survey

Downstream view of the site. Note the siphon pipe and pump.

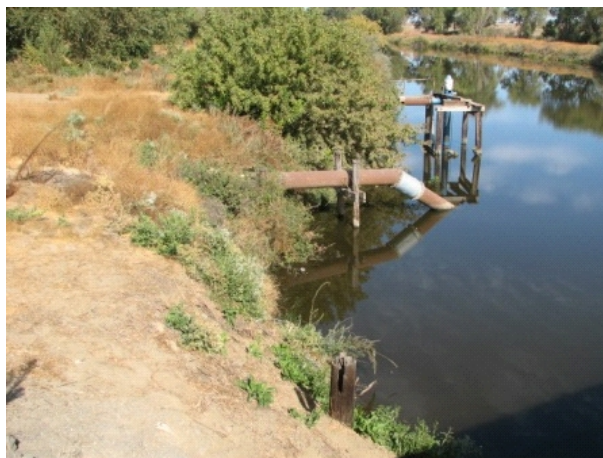
Levee Mile Report Line	6
Start Levee Mile	0.73
End Levee Mile	0.74
Location	Water Side
Category	Supplemental
Item	DWR Erosion Survey

Downstream view of the site.

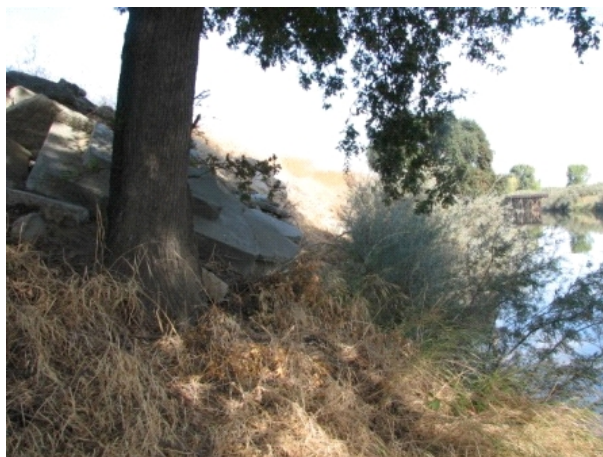
Levee Mile Report Line	7
Start Levee Mile	0.86
End Levee Mile	0.86
Location	Water Side
Category	Supplemental
Item	DWR Erosion Survey

Downstream view of iste.

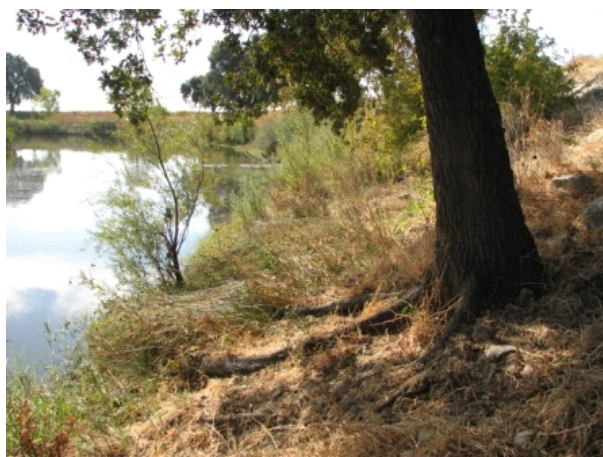
Levee Mile Report Line	7
Start Levee Mile	0.86
End Levee Mile	0.86
Location	Water Side
Category	Supplemental
Item	DWR Erosion Survey

Upstream view of site.

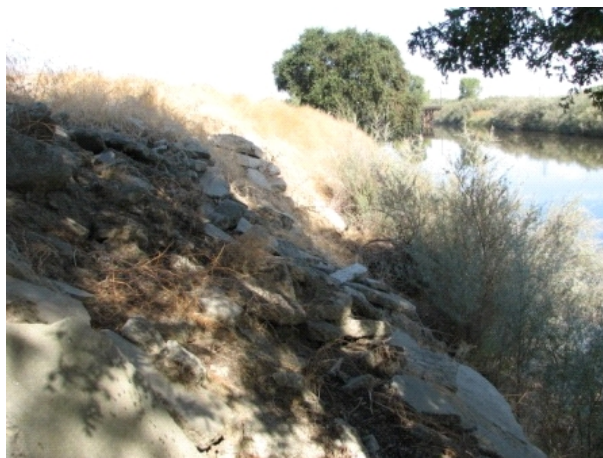
Levee Mile Report Line	7
Start Levee Mile	0.86
End Levee Mile	0.86
Location	Water Side
Category	Supplemental
Item	DWR Erosion Survey

Downstream view of site.

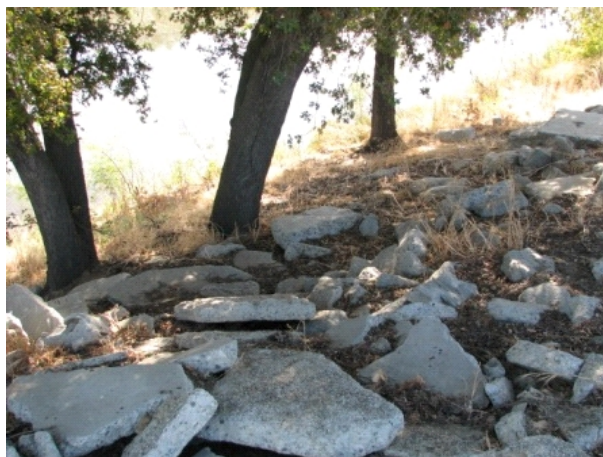
Levee Mile Report Line	7
Start Levee Mile	0.86
End Levee Mile	0.86
Location	Water Side
Category	Supplemental
Item	DWR Erosion Survey

Upstream view of site from upper slope.

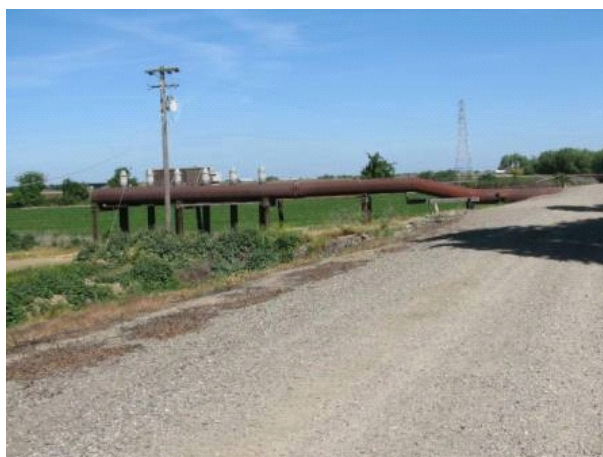
Levee Mile Report Line	8
Start Levee Mile	0.88
End Levee Mile	0.88
Location	Land Side
Category	Earthen Levee
Item	Encroachments

8	0.88	0.88	Earthen Levee	Encroachments	LS	W	Pipe Inspector Comments: Large pump platform for drainage into San Joaquin River. Three pumps. No positive closure devices. Pipe penetrates levee freeboard. No flap gate at outlet.	37.761362 ° -121.318062 °	37.761362 ° -121.318062 °	15 Y
9	0.88	0.88	Earthen Levee	Encroachments	WS	W	Pipe Inspector Comments: Gravity drain through base of levee. Positive closure on waterside hinge point. Flap gate obstructed by debris has been cleared.	37.761337 ° -121.318047 °	37.761337 ° -121.318047 °	16 Y
10	0.92	0.92	Earthen Levee	Encroachments	LS	M	Pipe Inspector Comments: North pipe is disconnected from pump with no closure devices or flap gate. Pipe runs through levee freeboard. Corrosion on waterside outlet. Hole cut on waterside hinge point where syphon breaker should be. 04/27/2011 situation unchanged. Picture attached	37.760758 ° -121.317720 °	37.760758 ° -121.317720 °	17 Y

04/27/2011 Pumps at LM 0.88

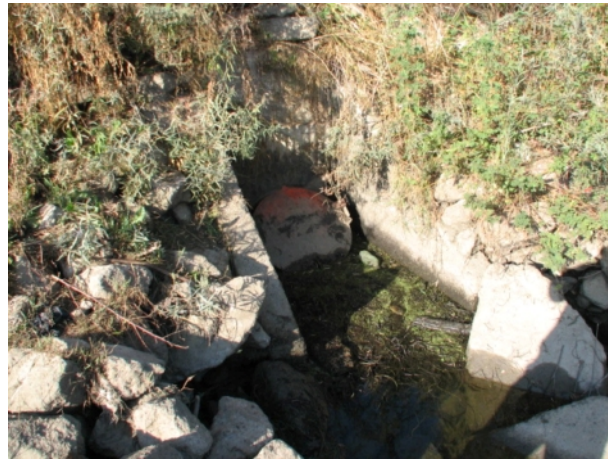
Levee Mile Report Line	9
Start Levee Mile	0.88
End Levee Mile	0.88
Location	Water Side
Category	Earthen Levee
Item	Encroachments

Gravity drainage outlet flapgate blocked by debris.

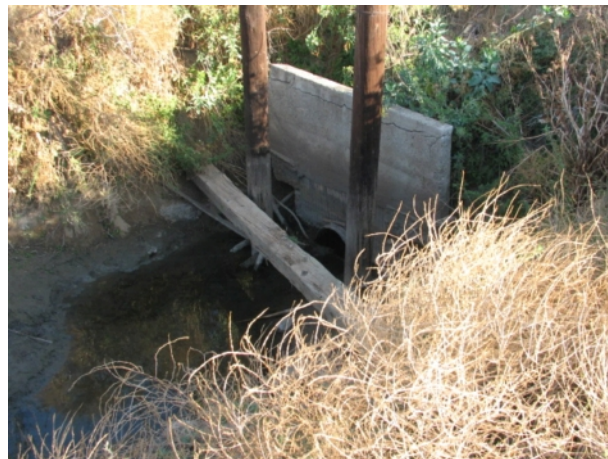
Levee Mile Report Line	9
Start Levee Mile	0.88
End Levee Mile	0.88
Location	Water Side
Category	Earthen Levee
Item	Encroachments

Gravity drain inlet.

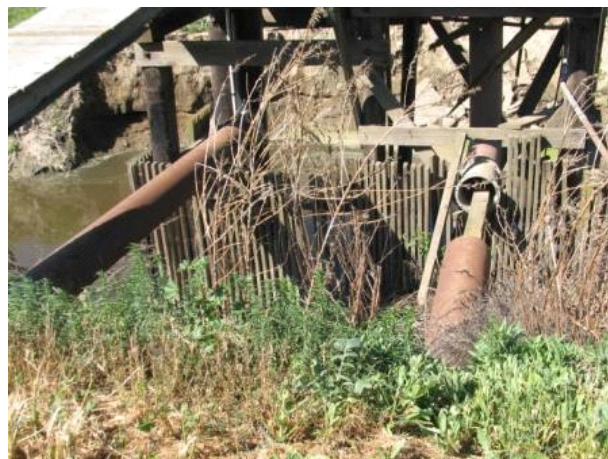
Levee Mile Report Line	10
Start Levee Mile	0.92
End Levee Mile	0.92
Location	Land Side
Category	Earthen Levee
Item	Encroachments

04/27/2011 photo shows disconnected north pipe on the right. Situation has not changed since Fall 2010 inspection.

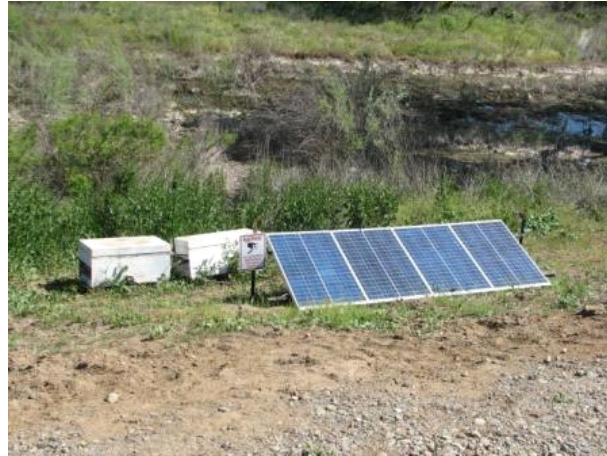
Levee Mile Report Line	12
Start Levee Mile	1.18
End Levee Mile	1.18
Location	Water Side
Category	Earthen Levee
Item	Encroachments
4/27/2011 Solar powered fish monitoring equipment.	
jeto_s_20110427_450.jpg

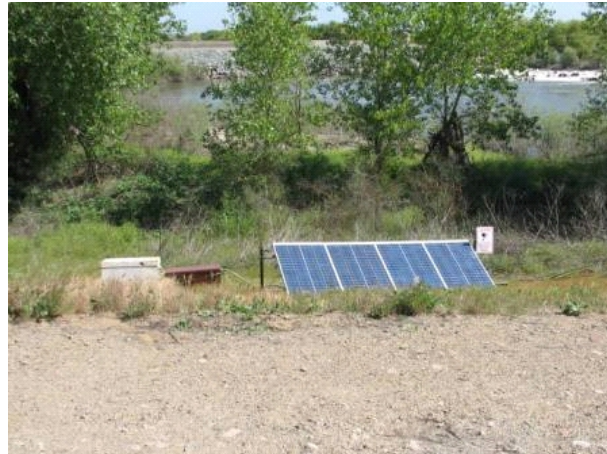
Levee Mile Report Line	13
Start Levee Mile	1.34
End Levee Mile	1.34
Location	Water Side
Category	Earthen Levee
Item	Encroachments
04/27/2011 Department of Fish and Game fish monitoring equipment.	
jeto_s_20110427_451.jpg

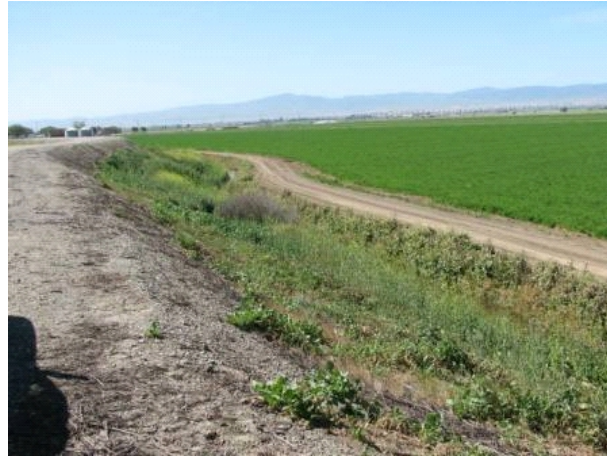
Levee Mile Report Line	1
Start Levee Mile	0.33
End Levee Mile	0.38
Location	Land Side
Category	Earthen Levee
Item	Vegetation
04/27/2011 Landside vegetation is inhibiting visibility of the landside slope.	
jeto_s_20110427_452.jpg

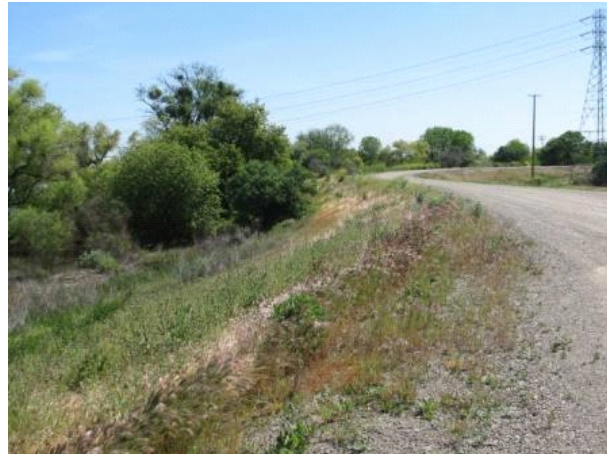
Levee Mile Report Line	7
Start Levee Mile	0.87
End Levee Mile	1.02
Location	Water Side
Category	Earthen Levee
Item	Vegetation
04/27/2011 Weeds taller than 12' on top 20' of landside slope.	
jeto_s_20110427_453.jpg

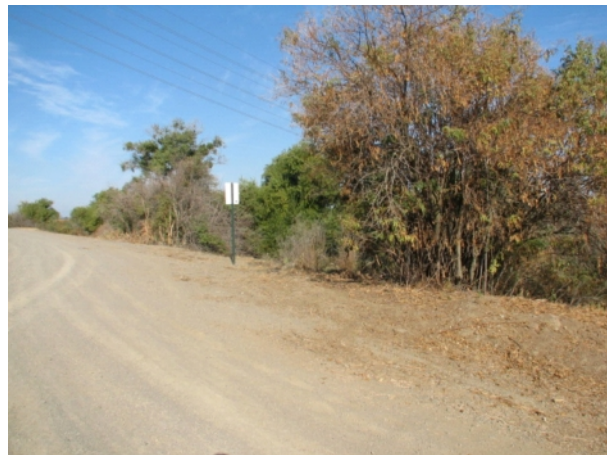
Levee Mile Report Line	9
Start Levee Mile	1.01
End Levee Mile	1.01
Location	Water Side
Category	Earthen Levee
Item	Vegetation
Elderberry blocks visibility of levee slope.	
jeto_s_20110301_270.jpg

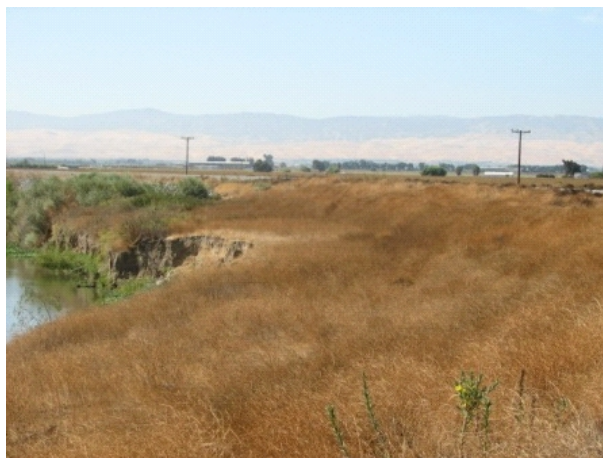
Levee Mile Report Line	15
Start Levee Mile	1.77
End Levee Mile	1.80
Location	Water Side
Category	Supplemental
Item	DWR Erosion Survey

Upstream view of the site from the levee crown.
Note the dense vegetation on the berm.

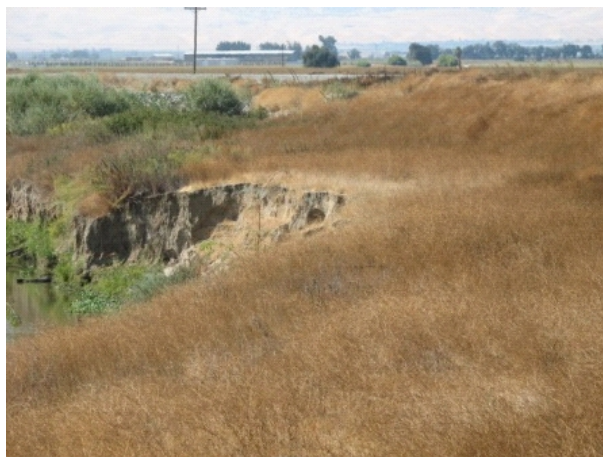
Levee Mile Report Line	15
Start Levee Mile	1.77
End Levee Mile	1.80
Location	Water Side
Category	Supplemental
Item	DWR Erosion Survey

Upstream view of the site.

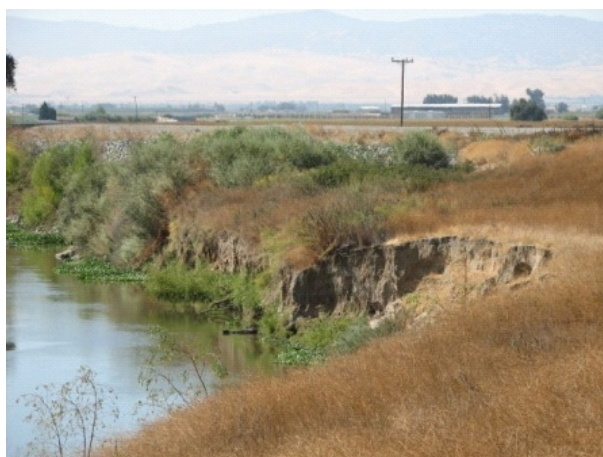
Levee Mile Report Line	15
Start Levee Mile	1.77
End Levee Mile	1.80
Location	Water Side
Category	Supplemental
Item	DWR Erosion Survey

Upstream view of the site.

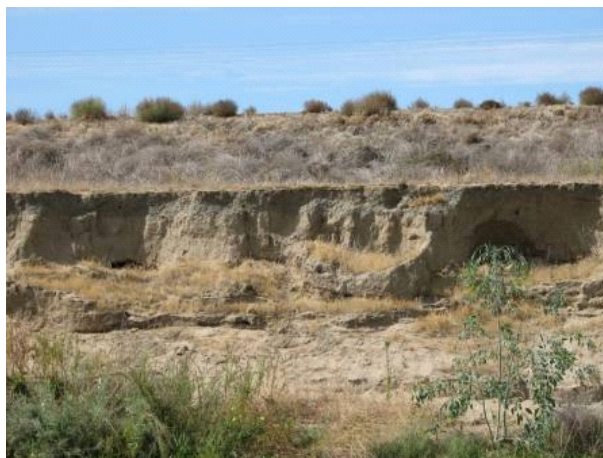
Levee Mile Report Line	15
Start Levee Mile	1.77
End Levee Mile	1.80
Location	Water Side
Category	Supplemental
Item	DWR Erosion Survey

Photo taken in 2009. Front view of the erosion from a boat.

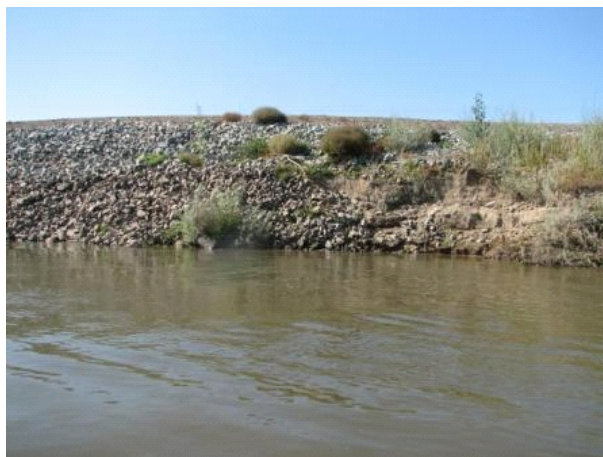
Levee Mile Report Line	16
Start Levee Mile	1.85
End Levee Mile	1.89
Location	Water Side
Category	Supplemental
Item	DWR Erosion Survey

LMR No.	Levee Mile		Category	Item	* Location	** Rating	Action/Comment	GPS Latitude/Longitude		Issue No. Photo
	Start	End						Start	End	
16	1.85	1.89	Supplemental	DWR Erosion Survey	WS	M	Inspector Comments: 09/23/2010: At the time of the inspection, the erosion site was difficult to view from the levee. Erosion is located on the bank toe, below the existing rip rap. There were no signs of repair on site, nor has the site been reported to be repaired by the d	37.738880 ° -121.298260 °	37.738880 ° -121.298260 °	2 Y
17	2.10	2.10	Earthen Levee	Encroachments	WS	W	Pipe	37.735483 ° -121.297912 °	37.735483 ° -121.297912 °	19
18	2.14	2.14	Earthen Levee	Vegetation	WS	M	Elderberries are blocking visibility and flood fight capability.	37.734858 ° -121.297758 °	37.734858 ° -121.297758 °	20 Y
19	2.39	2.39	Earthen Levee	Encroachments	CR	W	Pipe	37.731555 ° -121.298283 °	37.731555 ° -121.298283 °	23
20	2.54	2.54	Earthen Levee	Encroachments	WS	W	Equipment Inspector Comments: Fish monitoring station	37.729395 ° -121.299080 °	37.729395 ° -121.299080 °	10 Y

Direct view of erosion. Photo taken in 2009.

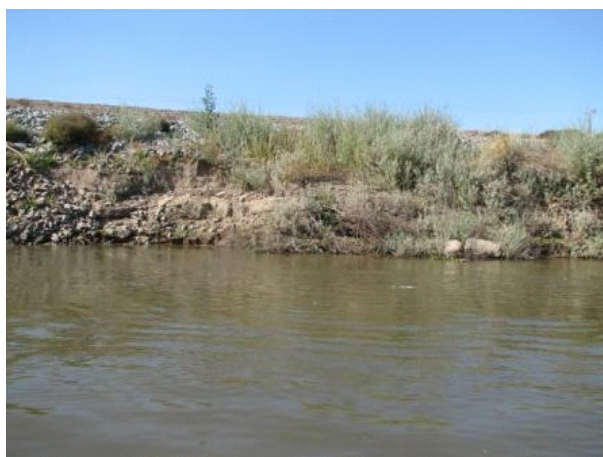
Levee Mile Report Line	16
Start Levee Mile	1.85
End Levee Mile	1.89
Location	Water Side
Category	Supplemental
Item	DWR Erosion Survey

Downstream view of erosion. Note emergent vegetation on the extended berm. Photo taken in 2009.

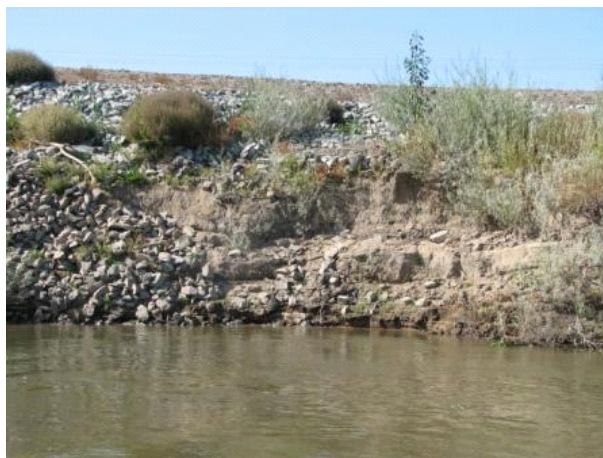
Levee Mile Report Line	16
Start Levee Mile	1.85
End Levee Mile	1.89
Location	Water Side
Category	Supplemental
Item	DWR Erosion Survey

Direct view of erosion. Erosion is occurring at the bank, just below the existing rip rap. Photo taken in 2009.

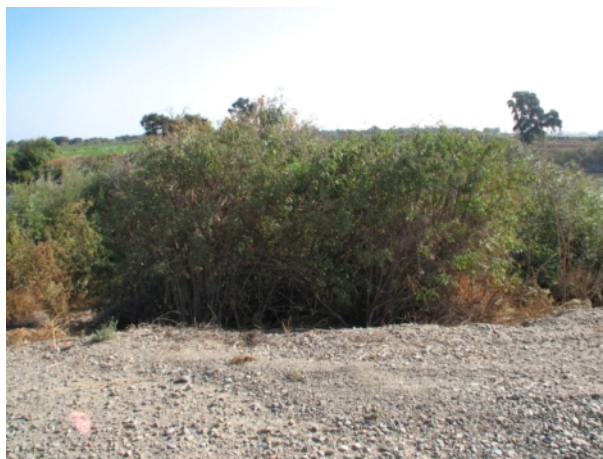
Levee Mile Report Line	18
Start Levee Mile	2.14
End Levee Mile	2.14
Location	Water Side
Category	Earthen Levee
Item	Vegetation

Vegetation on waterside slope obstructs access and visibility.

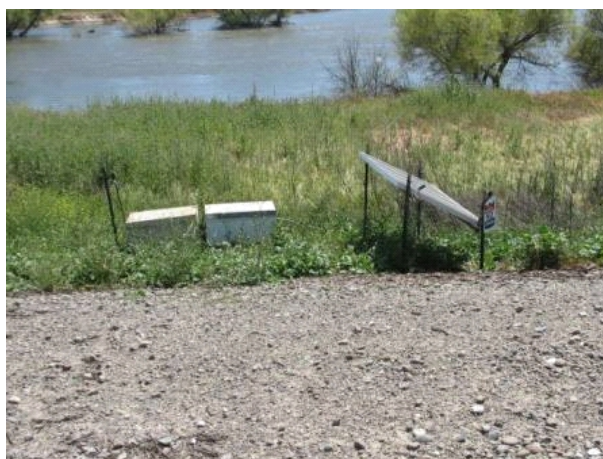
Levee Mile Report Line	20
Start Levee Mile	2.54
End Levee Mile	2.54
Location	Water Side
Category	Earthen Levee
Item	Encroachments

04/27/2011 Department of fish and Game solar powered fish monitoring station.
